Condition Based vs. Time Based Maintenance

Case Study on Hypergolic Pumps

Lewis Gibson

August 2007

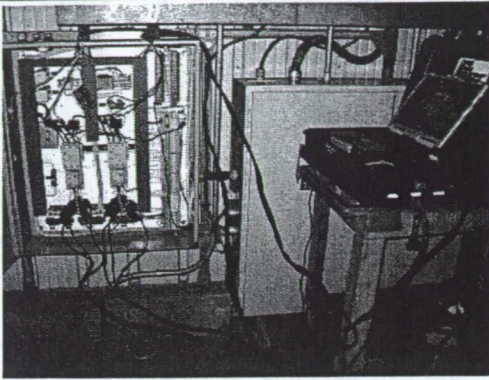
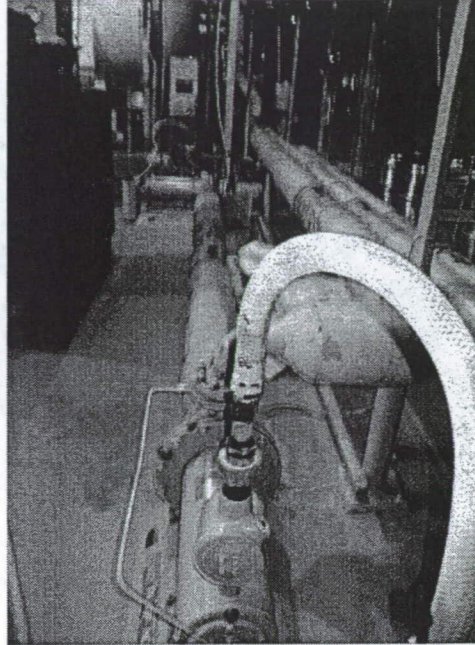
Test Set-up and Pad A pumps

Test set-up 7-22-2007 04:00

Not a typical set-up for these pumps, Baker loaned another tester so both pumps could be tested at the same time.

(Right picture) Pump #1 is at top center, discharge of this pump is rotated 90 deg so it's a straight shot to Pump#2.

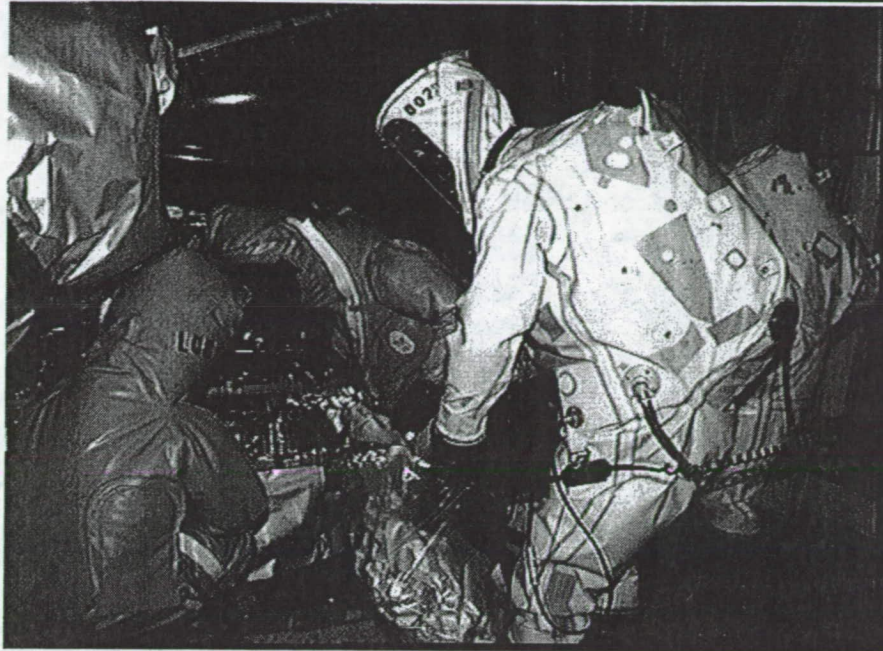
Propellant Servicing

SCAPE operations for S00024; Pad is cleared, only personnel in SCAPE suits are allowed on Pad or at the Farms. Oxidizer is loaded then Fuel.

- Flow is established up the tower and re-circulates back to the storage area.
- Once flow is detected at the skid inlets, flow is established in the skids and a leak checks of the skids are performed.
- Flow in the skids is maintained throughout the loading process.
- The FWD and AFT tanks are loaded in parallel.
- In the AFT, the OMS tanks are loaded first. Left OMS is loaded and then the Right OMS.(Fuel loads the right first then the left)
- Once OMS tanks are loaded the AFT RCS tanks are loaded. Left first then right. (Fuel loads the right first then the left)
- When both the FWD and AFT tanks are loaded and everyone is satisfied with the numbers, flow termination is initiated.
- Pumps are shut down and propellant freefalls back to the storage area.
- Blow downs are performed from the tower to the Storage

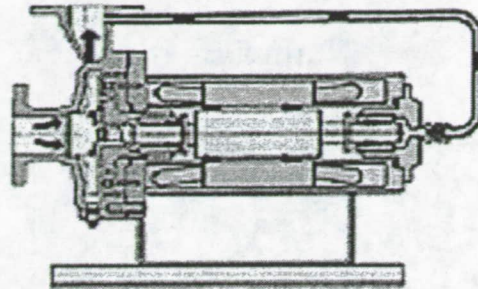
CRANE CHEMPUMP Series G

For normal clear fluid applications, Series G Chempumps are cooled and lubricated by the fluid being pumped, which flows through the circulating tube, into the rear of the rotor chamber, across the rear bearing, rotor, and front bearing, and then back into the main pumped stream through small holes provided in the rear of the impeller in the suction area.

Rotor and stator are jacketed in Stainless steel. Primary failure mode concern; rotor stator contact and breaching jacket on stator which would result in an explosion and release of toxic propellants.

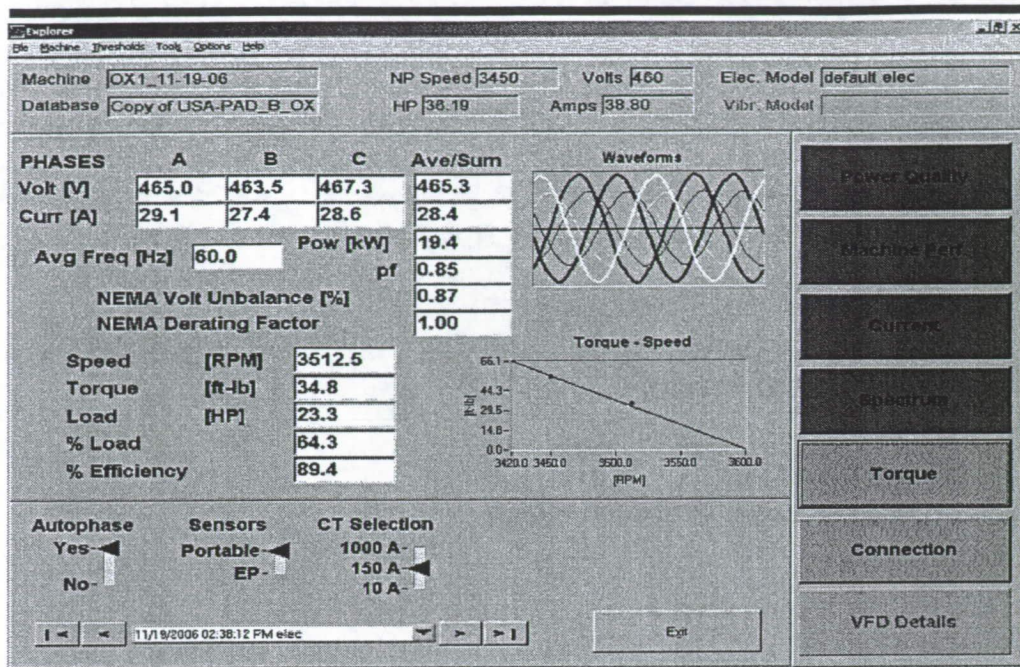
The first test we will show was taken on Pad B Oxidizer #2 in November of 2006.

This is just one of 23 runs captured on Pump #1 in November of 2006. No problems noted on the front panel, except the speed is off but that is not apparent right now.

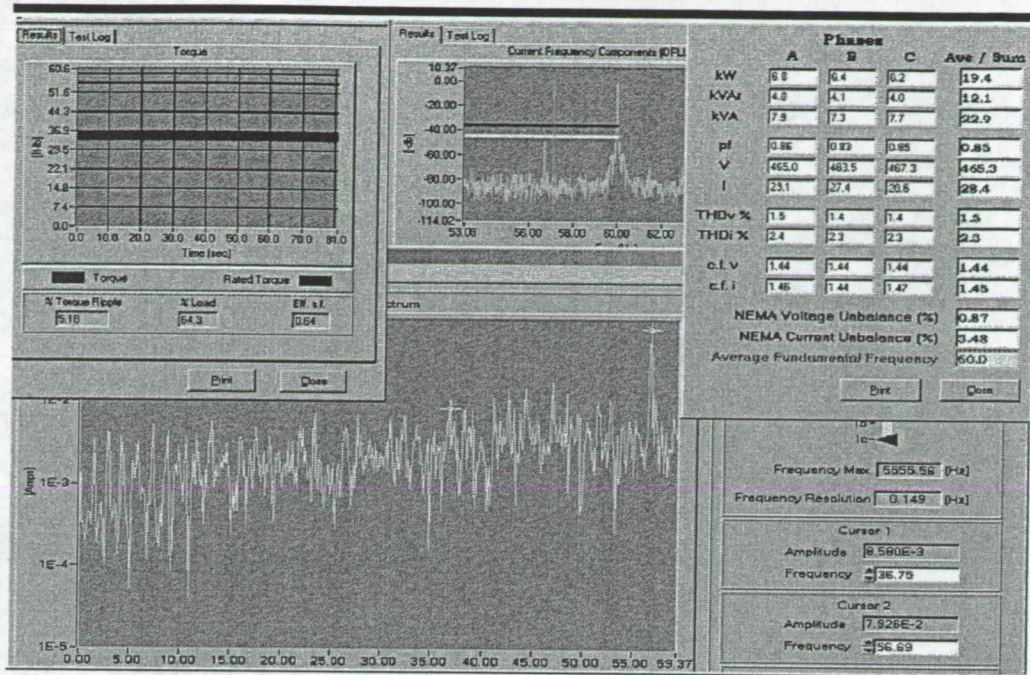
SC4

Torque ripple looks ok at ~5%, rotor bar sidebands appear to be ok. Note speed capture is incorrect, this may be due to the very high slip of these motors. Current spectrum (0-60 Hz) looks good, and all other electrical data looks nominal.

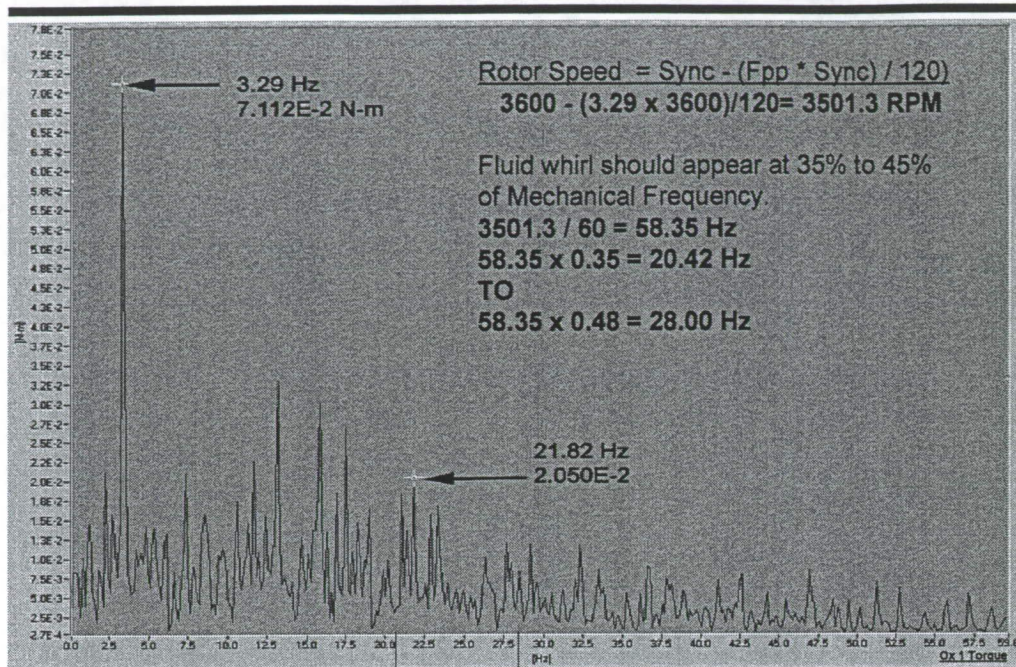
Linear plot of Torque spectrum taken at the same time. The peak at 3.29 Hz is the Fpp (Frequency Pole Pass). Rotor speed can be calculated from this peak very accurately using the following formula ...

$\text{Sync} - (\text{Fpp} * \text{Sync}) / 120$ so $3600 - (3.29 * 3600)/120 = 3501.3 \text{ RPM}$.

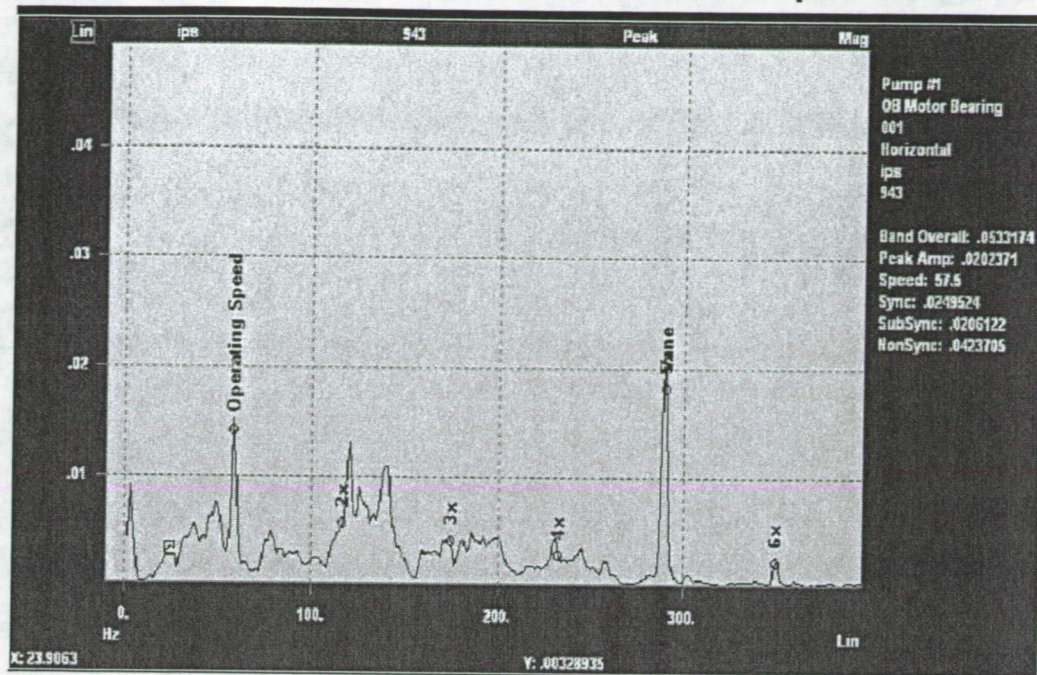
Vibration Spectrum

- **Explorer and Vibration analysis data are in agreement**
- **Pump healthy no fluid whirl**
- **Recommendation continue normal operations until 100 hour planned maintenance cycle**

The pump was determined to be healthy and we recommended to continue normal operations.

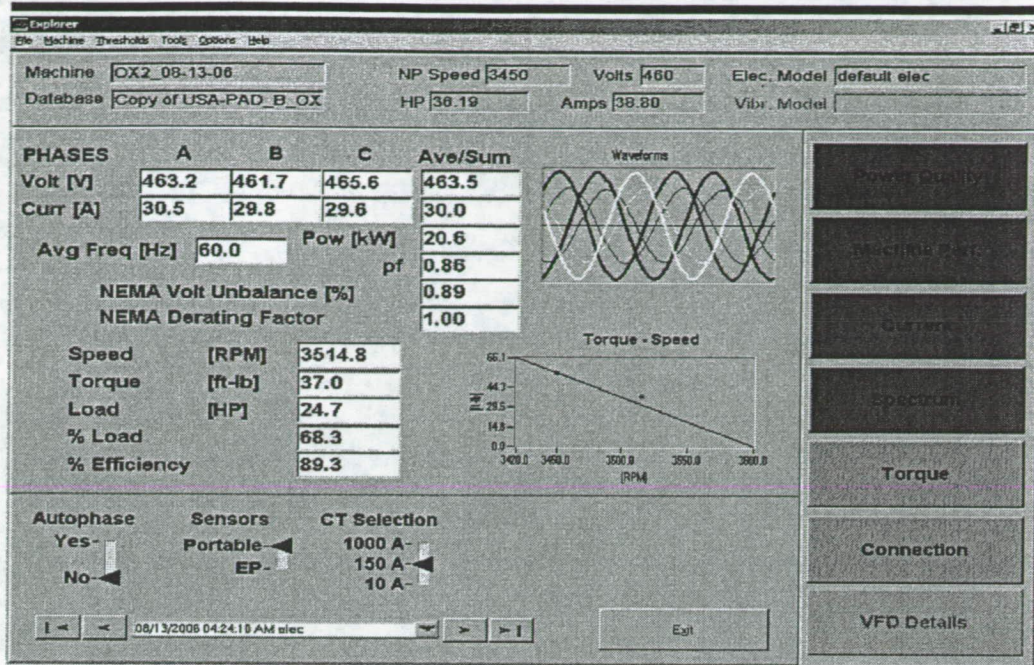
SC7

This is one of 34 runs captured in Aug 2006 on Pump #2. Again there are no apparent anomalies.

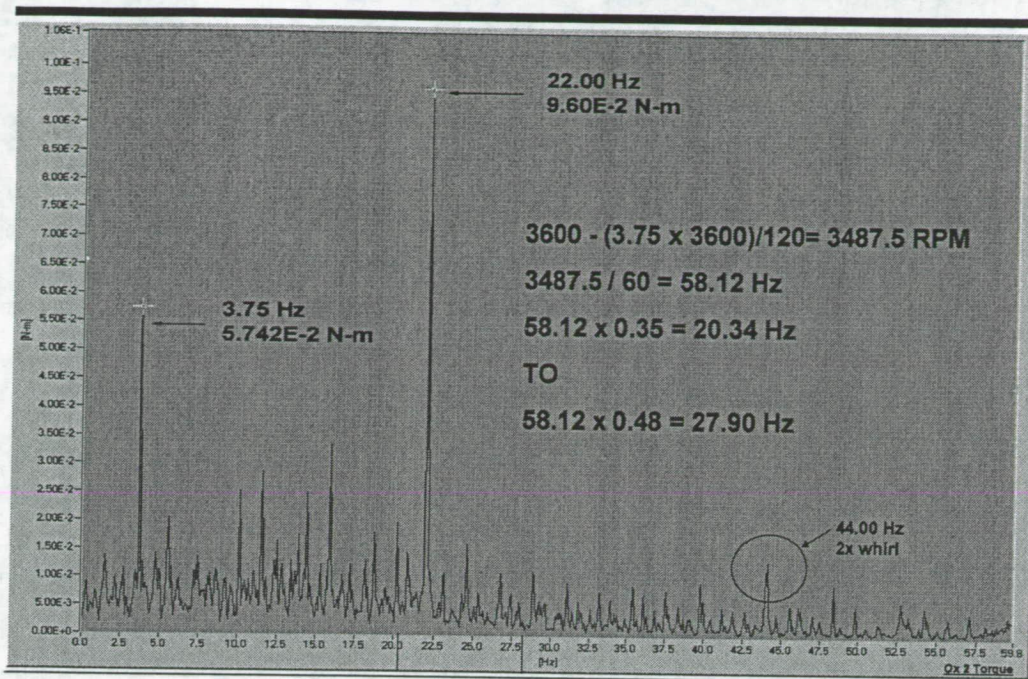
SC9

Linear plot of Torque spectrum. Fpp at 3.75 Hz = 3487.5 RPM (Note Pump 1 Fpp level was ~.07 N-m).

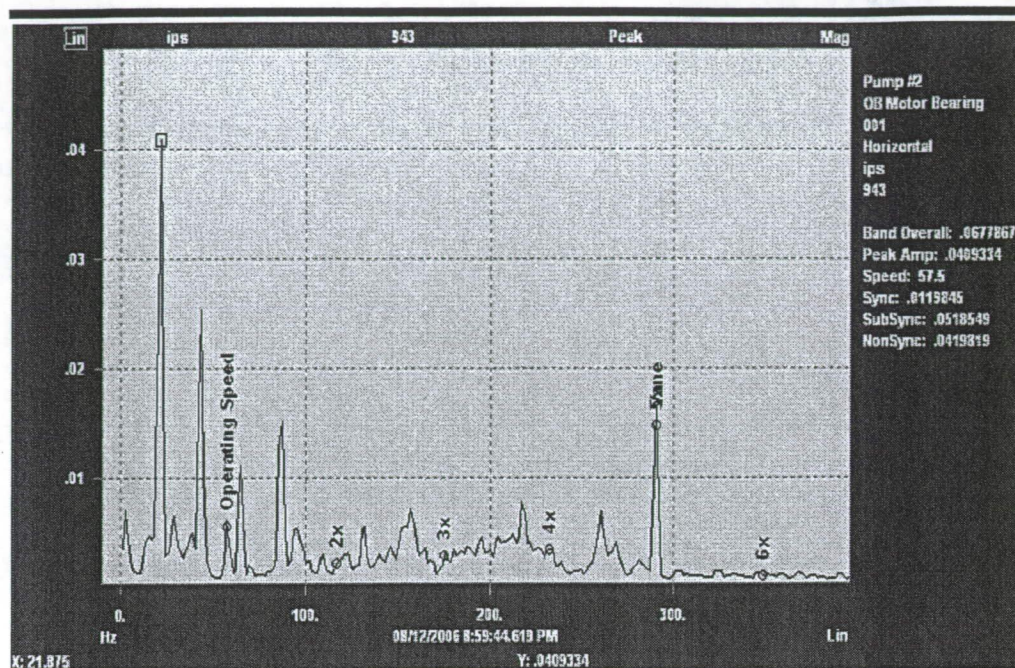
Vibration Spectrum

Vibration was taken the night before and also shows fluid whirl @ 21.87 Hz.

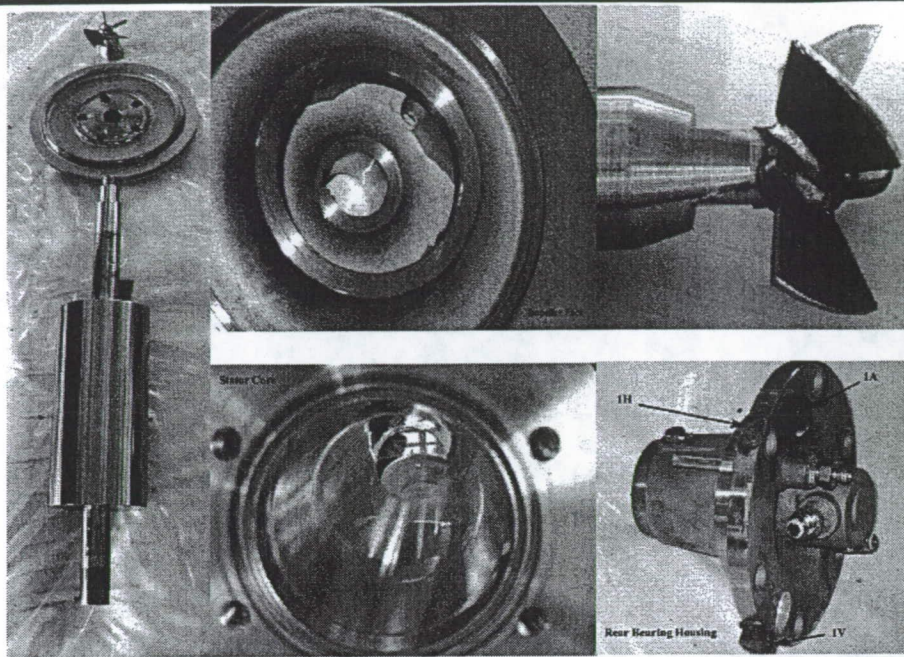
Pad B Ox #2 pump assembly

Pad B Ox#2 pump disassembled in March 2007. Clockwise from Left side; Rotor-impeller- and flow inducer, suction side of impeller, flow inducer, rear bearing housing, and the stator core.

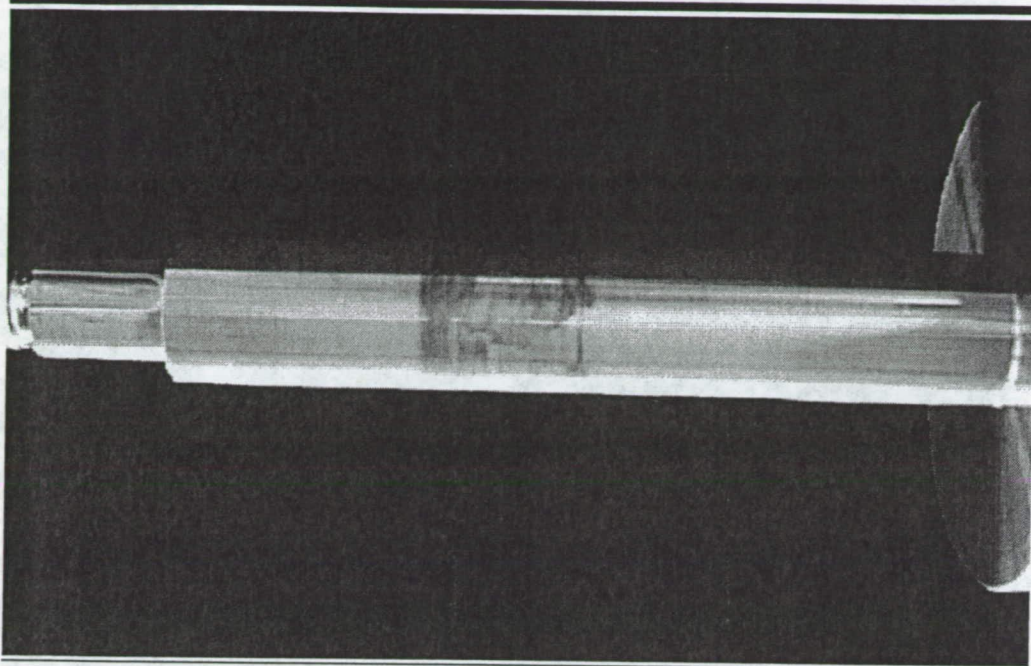
Front Journal Ox #1

Pad B Ox #1 front journal

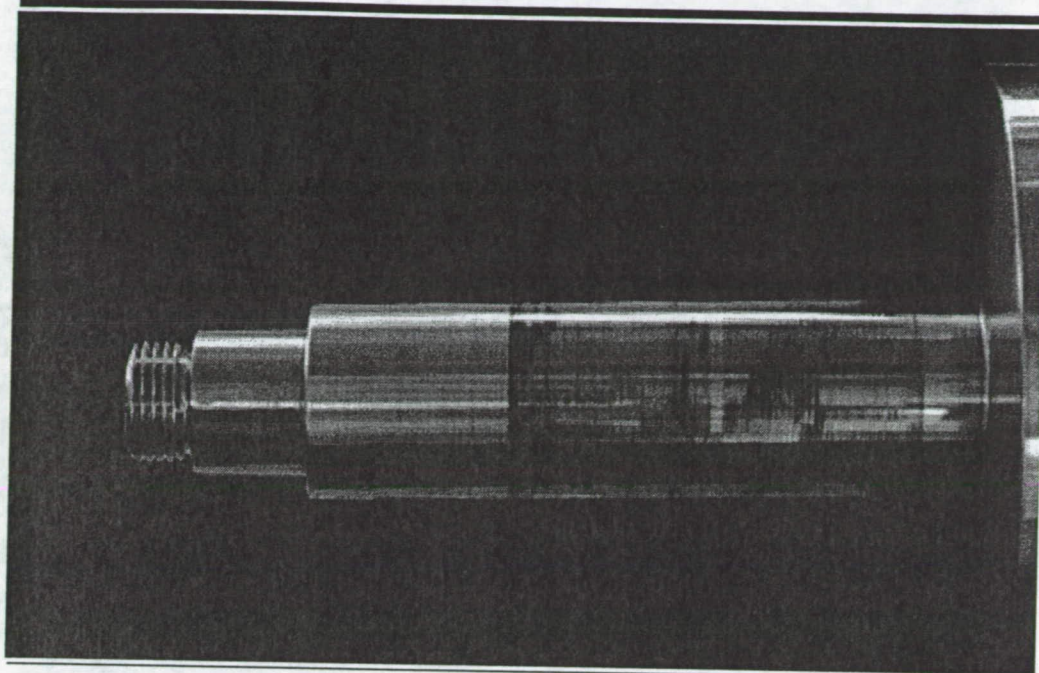
Front Journal Ox2

Pad B Ox #2 Front journal.

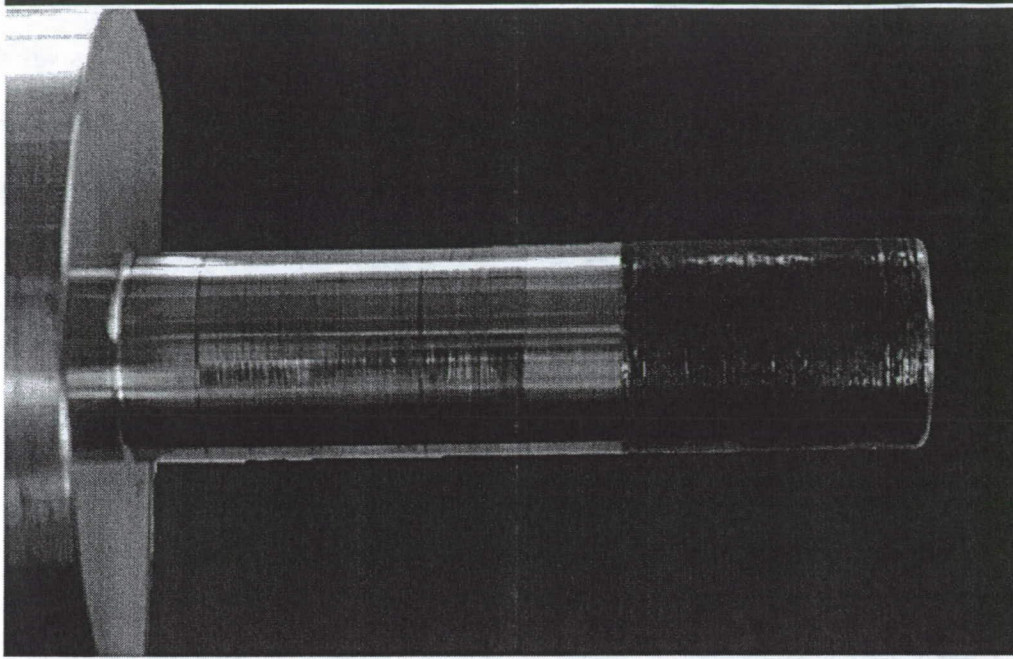
Rear Journal Ox2

Pad B Ox #2 Rear journal.

The same is true of the Front bearing on Oxidizer #2 but the rear bearing has considerable wear and is significantly out of tolerance. The 0.010" over MAX tolerance is believed to be why oil whirl was observed on Ox pump #2.

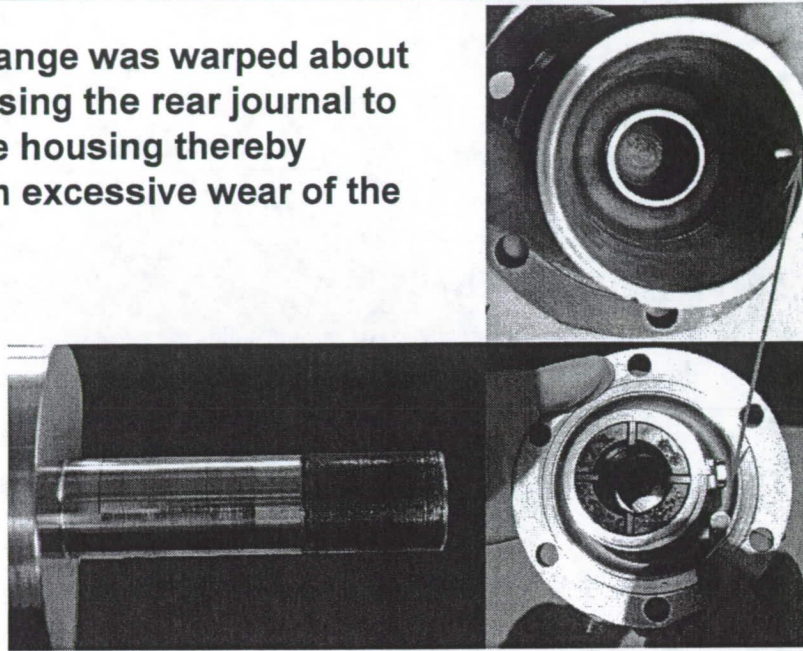
Root Cause of Pad B Ox Pump #2 Failure

Housing flange was warped about 0.020" causing the rear journal to contact the housing thereby resulting in excessive wear of the bearing.

The root cause of the rotor rub was suspected to be the rear bearing housing flange. It was found to be warped ~0.020".

•Pad B Ox 2 was disassembled first and showed significant wear on the rear bearing and also had significant rotor rub

•If condition based maintenance were used it would have been possible to salvage the rotor and bearing, if the pump was removed from service earlier

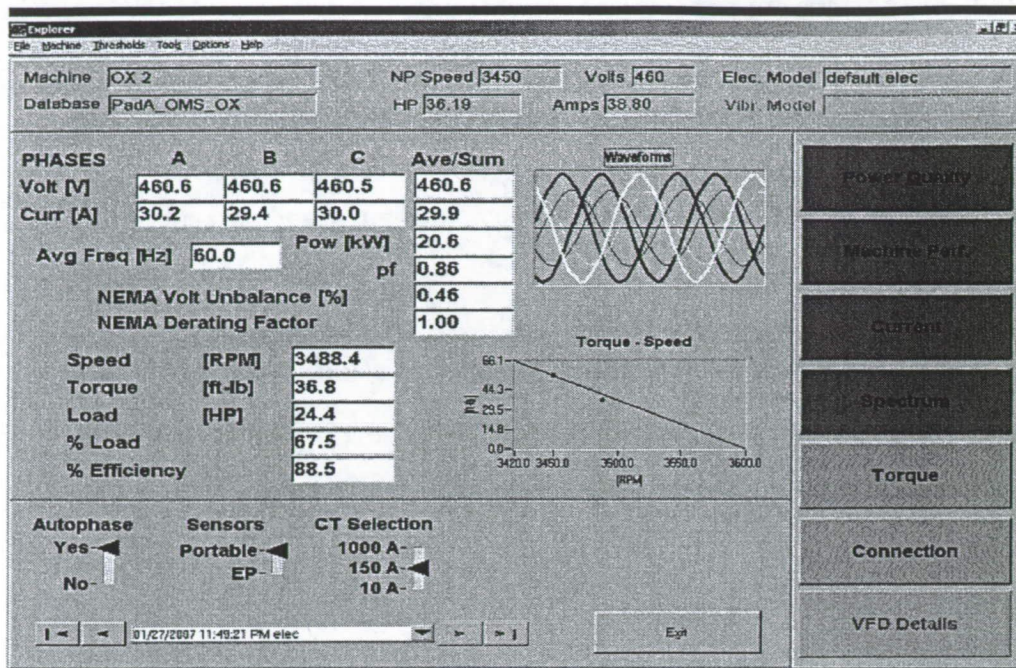
SC11

This is one of 17 runs captured in January 2007 at Pad A Pump #2. Again no apparent anomalies.

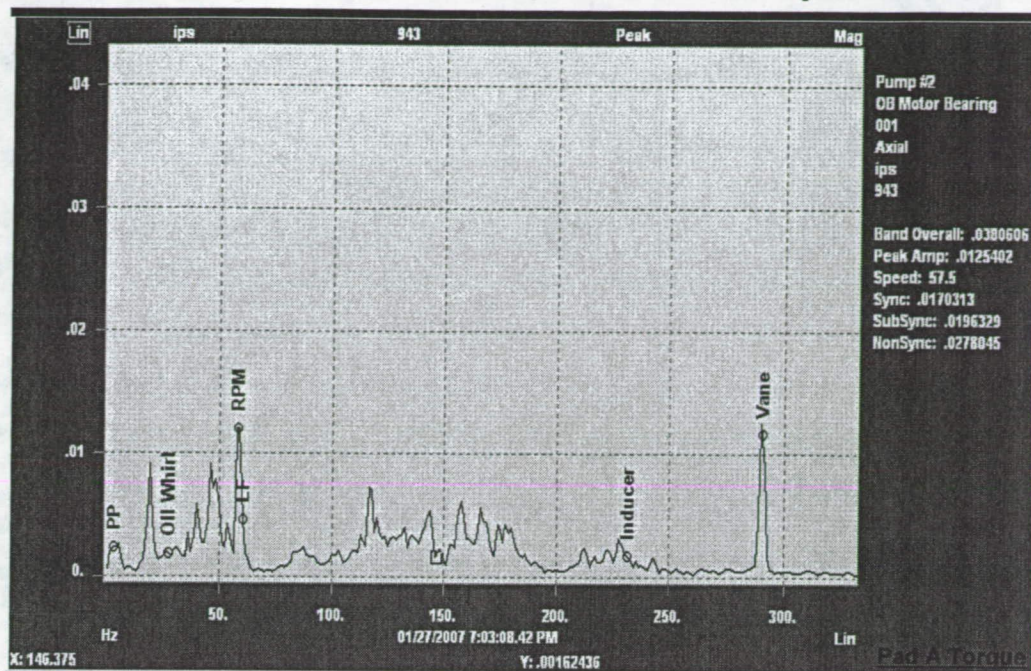
Vibration Spectrum

Vibration analysis reported fluid whirl in their report. This was not corroborated with the Explorer, which indicated the sub harmonic peak was a voltage distribution problem, there are SCR heaters on the bus which feeds these motors and the heaters were operating during this period.

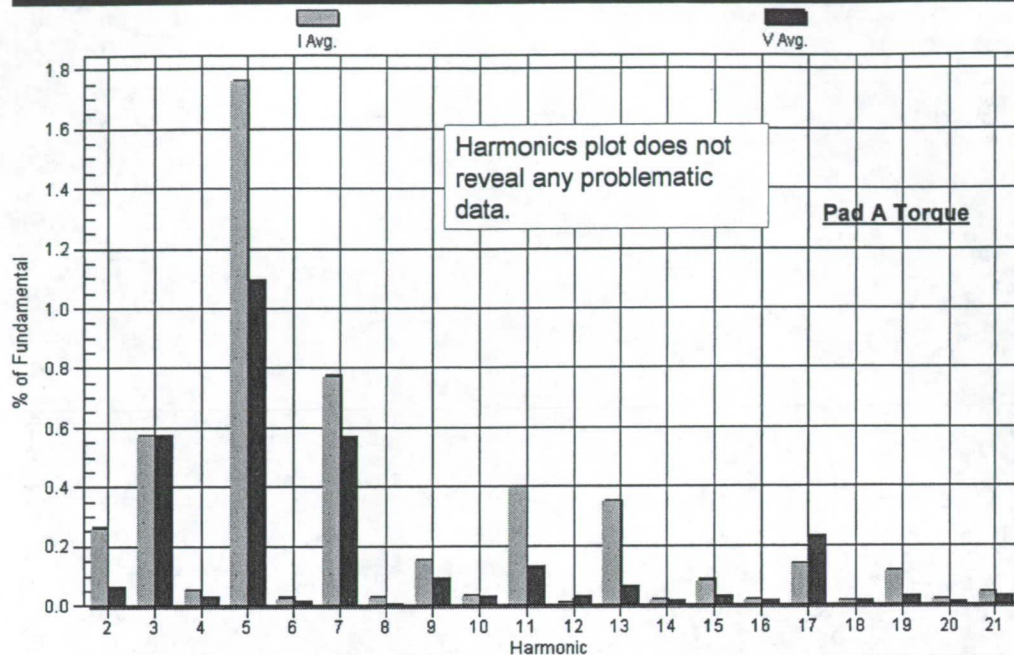
Harmonics Run 5

Harmonic data does not reveal problems with voltage, because there were sub-harmonics on the line not harmonics the Crest Factor for Current does increase when these sub harmonics appear but not the Crest Factor for Voltage.

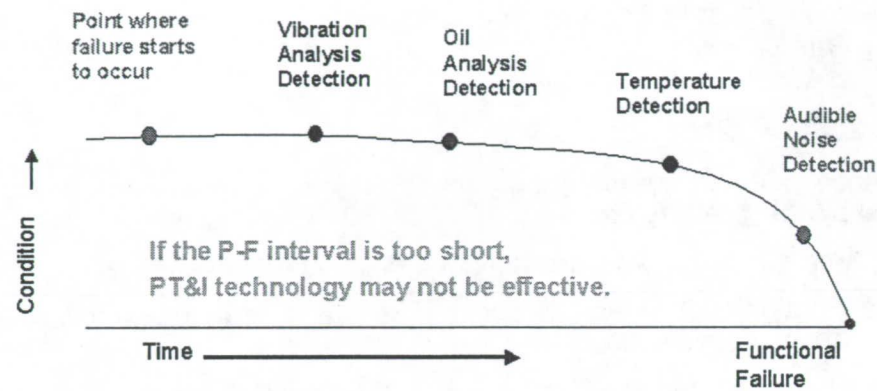
The P-F curve is used to illustrate where a failure starts to occur in the life of a piece of equipment and where each technology could possibly detect that failure. I don't like this curve too much because there is no one best analysis technique and it obvious, John Moubray came up with this before MCA was available... I doubt that but he may not have been aware of it's power.

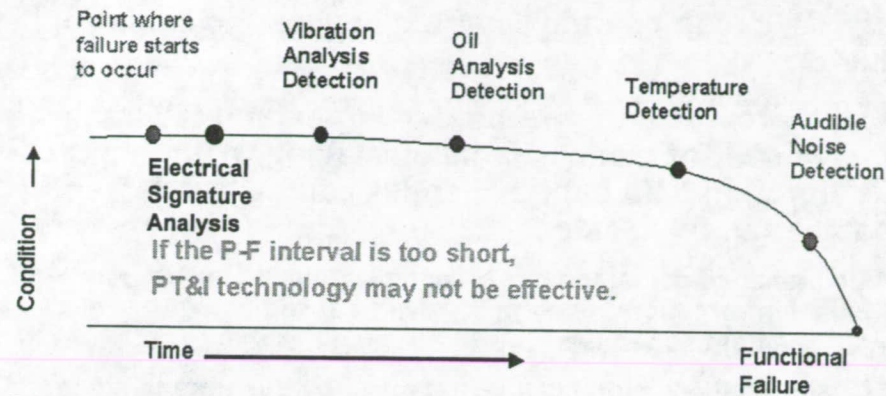
P-F curve (modified)

Now this looks better. But if you think about ESA has actually found a fault before it has started to degrade the system, remember the Pad A Heaters? If this problem is not addressed then problems could escalate.

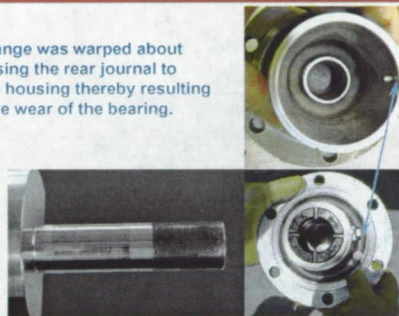
Housing flange was warped about 0.020" causing the rear journal to contact the housing thereby resulting in excessive wear of the bearing.
